Contract #: 04-0120F4Cty: SF/ALA Rte: 80 PM: 13.2/13.9File #: 13.28**WELDING INSPECTION REPORT****Resident Engineer:**Pursell, Gary**Address:** 333 Burma Road**City:** Oakland, CA 94607**Report No:** WIR-010777**Date Inspected:** 11-Dec-2009**Project Name:** SAS Superstructure**OSM Arrival Time:** 1000**Prime Contractor:** American Bridge/Fluor Enterprises, a JV**OSM Departure Time:** 1830**Contractor:** Oregon Iron Works Clackamas, Or.**Location:** Clackamas, OR**CWI Name:** M. Gregson, J. Salazar**CWI Present:** Yes No**Inspected CWI report:** Yes No N/A**Rod Oven in Use:** Yes No N/A**Electrode to specification:** Yes No N/A**Weld Procedures Followed:** Yes No N/A**Qualified Welders:** Yes No N/A**Verified Joint Fit-up:** Yes No N/A**Approved Drawings:** Yes No N/A**Approved WPS:** Yes No N/A**Delayed / Cancelled:** Yes No N/A**Bridge No:** 34-0006**Component:** Hinge K Pipe Beams**Summary of Items Observed:**

Hinge-K Pipe Beam Assembly 102A-3: 12/11/09

a111-3 Forging to a110-3 Base Plate

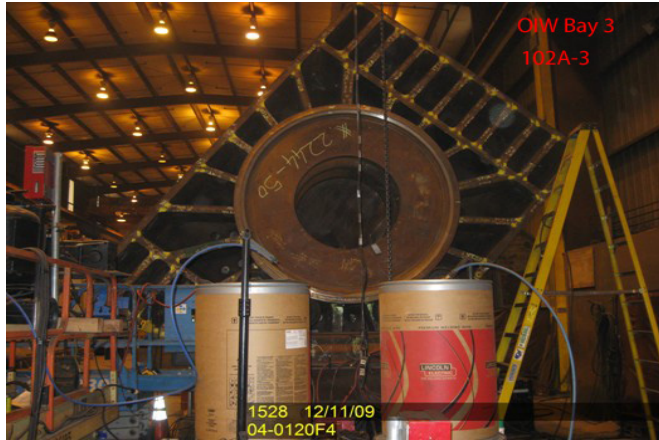
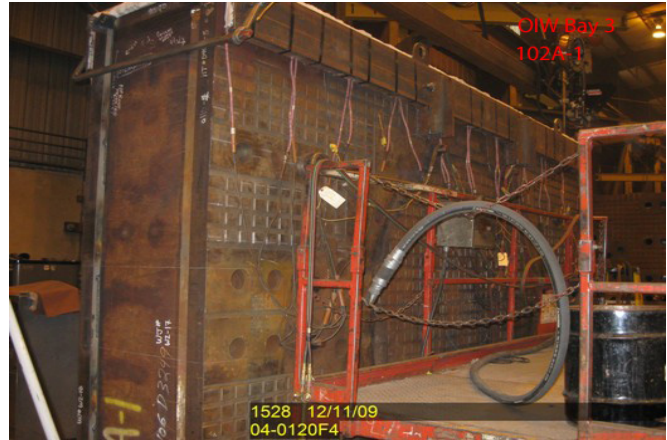
The QA Inspector noted that OIW welder # O6, Mr. Tim O'Brian was continuing to blend the weld start/stops, removing weld spatter and grinding all areas, which were previously marked by OIW QC Inspectors. The QA Inspector noted that these areas were on the previously completed submerged arc welded (SAW), HPS 485W stiffeners, designated as weld joints #W1-01 thru W1-163. The QA Inspector spoke with QC Inspector Jose Salazar and Mr. Salazar explained that the visual clean-up that was being performed by Mr. O'Brian, was intermittently monitored and areas that were completed, were then visually re-inspected. See attached pictures below.
